DELAWARE RIVER BASIN
LAHAWAY CREEK, OCEAN COUNTY
NEW JERSEY

PROSPERTOWN DAM

NJ00455

PHASE 1 INSPECTION REPORT NATIONAL DAM SAFETY PROGRAM

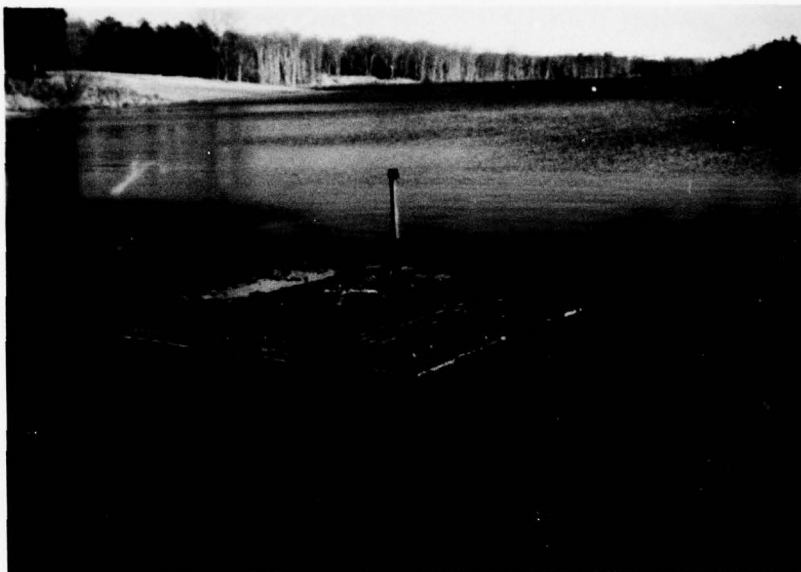
PHOTO 1
SPILLWAY STRUCTURE

Most of the principal spillway was submerged or buried, and therefore could not be inspected. At the lake surface the spillway was enclosed by a square asphalt coated corrugated sheet metal structure with a grated opening in the center. Slight debris collection was noted on the grate, otherwise it was in good condition with some rust at the water level where the coating was not intact

- 6) Tall grass in the auxiliary spillway channel should be cut and maintained at a lower height.
- 7) Vegetation hanging over the downstream channel, and brush and small trees in the flood plain between the dam and the Route 537 bridge should be removed.
- 8) The asphalt coating on the anti-vortex assembly should be renewed after rust is removed.

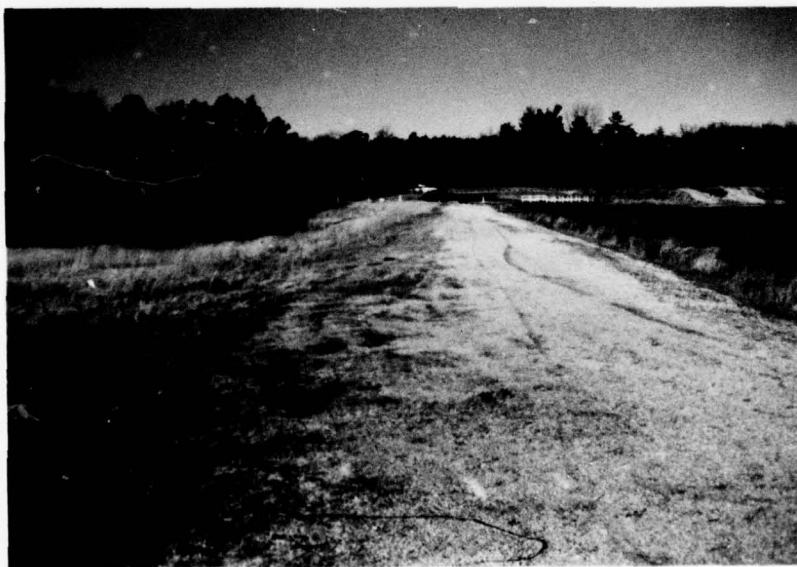
PHOTO 2
CREST OF DAM

Erosion was observed at the north end of the embankment crest at the edge of an asphalt paved parking area. Pavement was undermined and breaking off at this boundary.

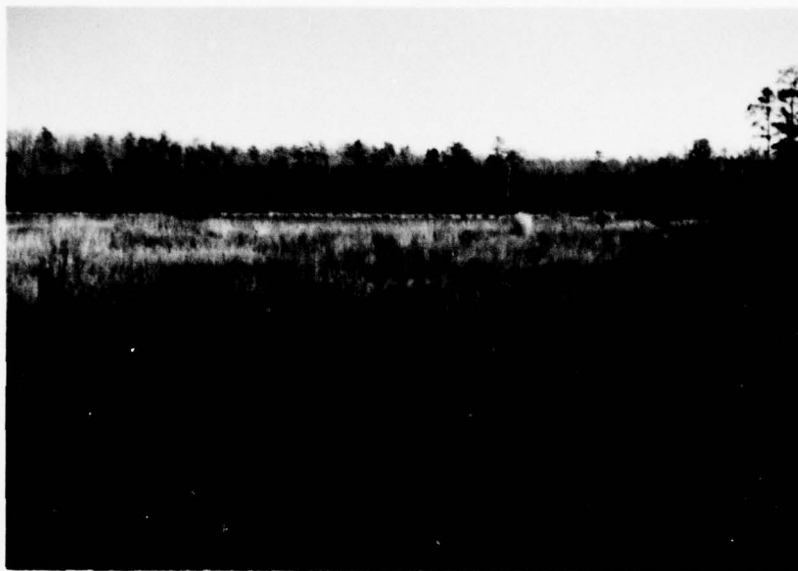
PHOTO 5
AUXILIARY SPILLWAY

The auxiliary spillway consists of a trapezoidal grassed channel, essentially in present appearance as designed and constructed. Vehicle tracks and ruts were observed at

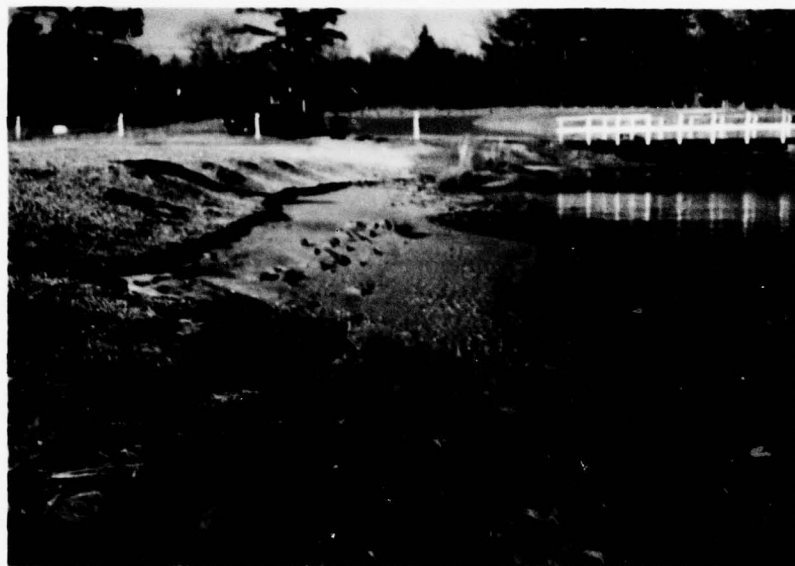
PHOTO 9

REMAINS OF RIPRAP ON UPSTREAM FACE OF EMBANKMENT
